SERVICE BULLETIN

TM-2570 LOW TX POWER OUTPUT

3-18-86

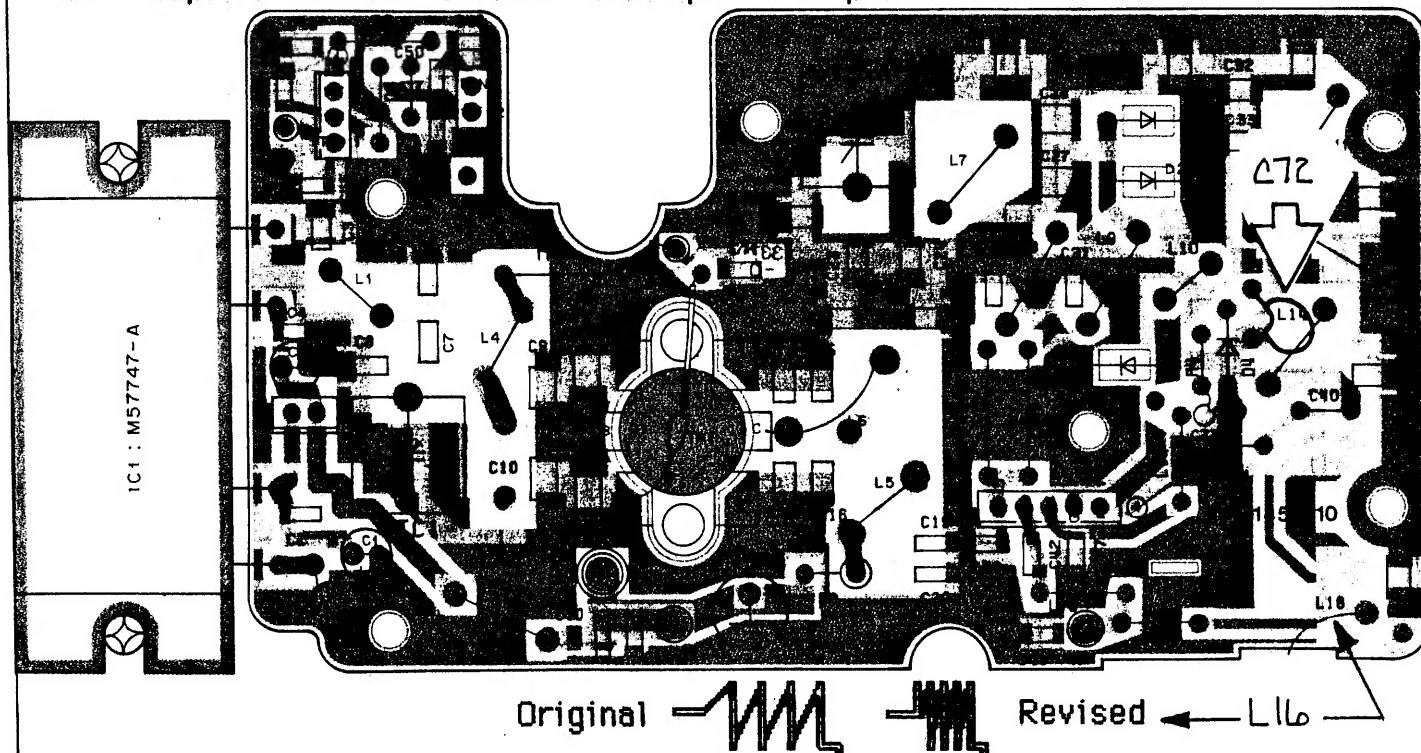
Some owners of the TM-2570 have reported low transmitter power when the radio is used with an antenna having reasonably low VSWR (1.5:1).

1. Remove the bottom cover on the heat sink.
2. Ensure that C72 is in the location indicated below. Note: Some radios may have C72 installed in the wrong position, check carefully.
3. Squeeze the coils of L16 closer together.
4. Make sure that C72 and L14 are as far away from each other as possible, move the capacitor, not the inductor.
5. Readjust VR1-VR4, according to the instructions provided in the Service Manual. The protection circuit (VR4), should be adjusted for 8A at 146.000 Mhz rather than the values indicated in the Service Manual. Change your Service Manual to reflect this value.
6. Replace the bottom cover to complete the procedure.
